Lake Independence Shoreline Restoration Final Report 2020

Lake Independence shoreline restoration was proposed at Lakeshore Park in the City of Medina to reduce shoreline erosion. The project addressed significant erosion along 160 linear feet of shoreline located within Lakeshore Park (Figure 1 & 2). The erosion contributes approximately 2 pounds of phosphorus loading per year to Lake Independence. The project protects the shoreline from continuous wind and wave action as well as ice scour by installing a combination of riprap and native plantings.

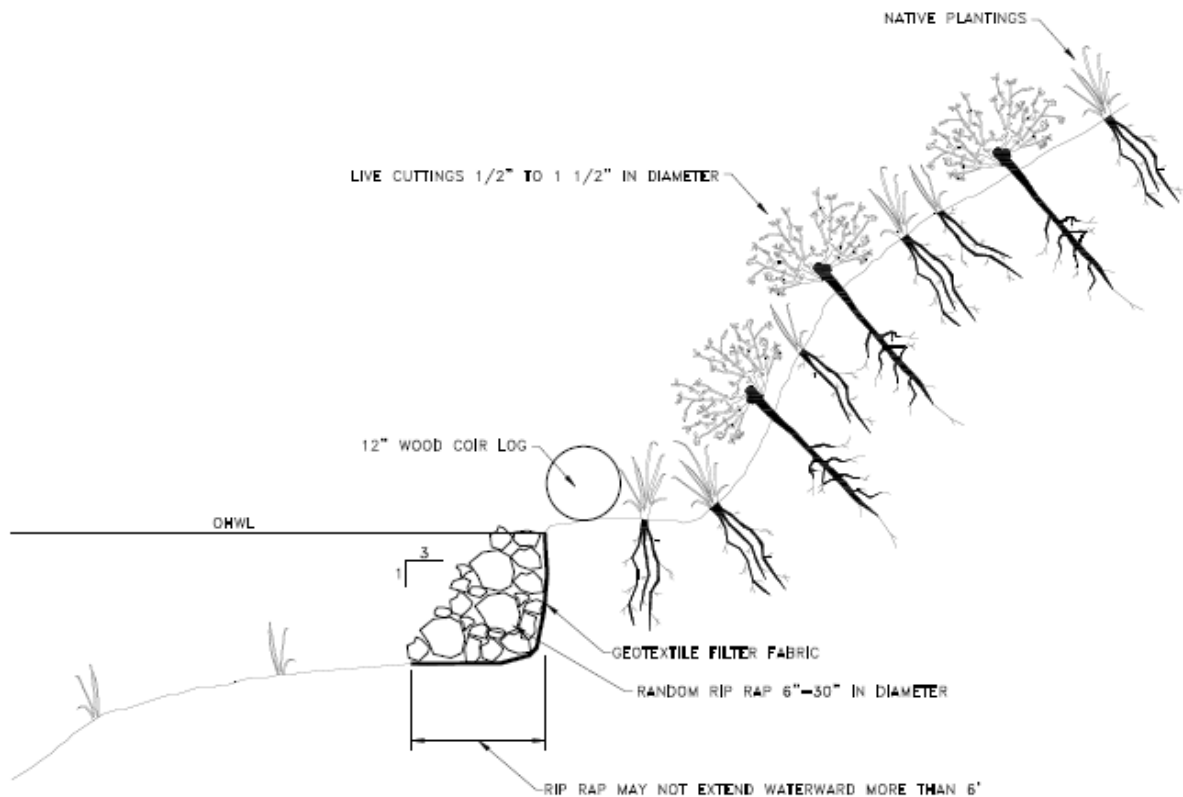
Figure 3: Design for shoreline stabilization.

The riprap was installed to an elevation of active erosion in accordance with the Minnesota Department of Natural Resources permit conditions. There was approximately 50 to 60 cubic yards of 6-inch to 30-inch boulder riprap installed on top of geotextile filter fabric (Figure 3). The riprap and geotextile fabric protected the shoreline from wind and wave action to the Ordinary High Water Level (OHWL) elevation. The riprap extended approximately 6 feet waterward to protect the shoreline from ice scour.

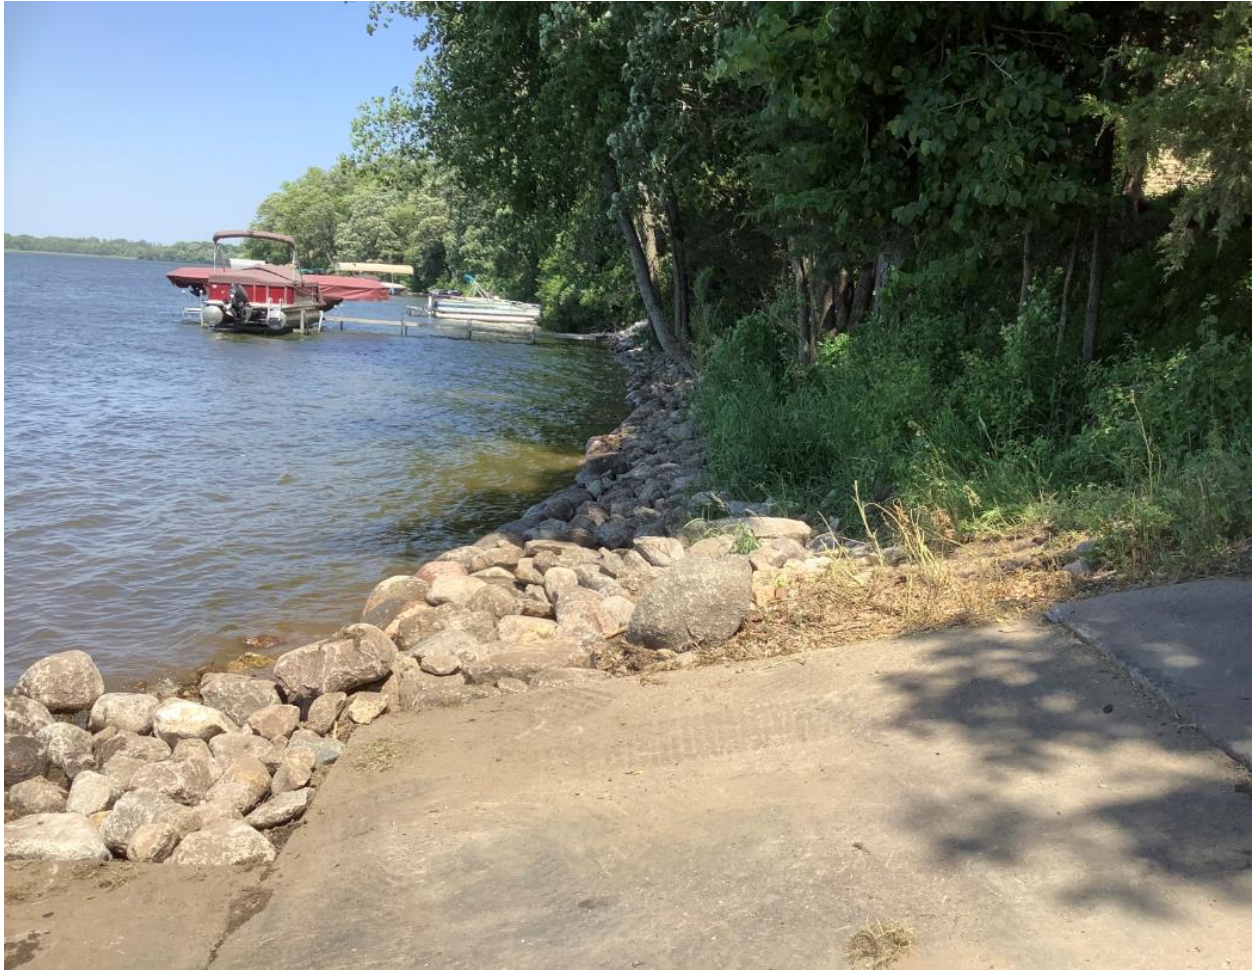
Figure 5: Lakeshore Park shoreline restoration project completed in 2020.

The Lakeshore Park shoreline restoration/stabilization project was completed in the summer of 2020 (Figure 5). It is anticipated that shoreline restoration will reduce future erosion attributed to wind/wave action and ice scour for estimated project life expectancy of 20 years. The project will require annual maintenance to ensure the establishment of a diverse native plant community to stabilize shore bank soils above the armor riprap elevation. It is estimated that the project will reduce phosphorus loading by approximately 2 pounds/year. This is a reduction of 40 pounds for the 20-year estimated life expectancy of the project. The total costs to complete the project was \$35,312.52. The overall cost benefit analysis was approximately \$883 per pound of phosphorus removed each year. The project was a partnership collaborative effort with the City of Medina, Hennepin County, Pioneer-Sarah Creek Watershed Management Commission, and the Board of Water and Soil Resources.

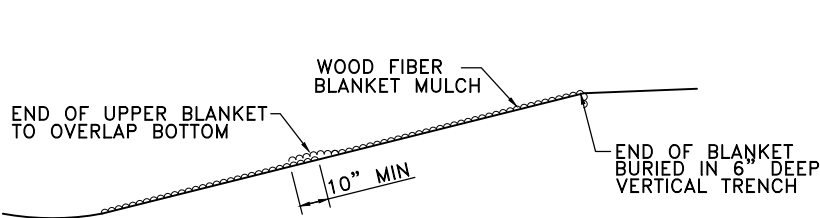
1
3 WOOD FIBER BLANKET
ON A SLOPE
NO SCALE

NOTE:
WOOD FIBER BLANKET SHALL BE PLACED AND STAPLED ACCORDING TO Mn/DOT SPECIFICATION 2575.3K2 WITH THE FOLLOWING EXCEPTIONS. ADJACENT STRIP EDGES SHALL BE OVERLAPPED A MINIMUM OF 6".

PLASTIC OR WOOD BIODEGRADABLE STAKES OR STAPLES SHALL BE USED IN PLACE OF METAL WIRE STAPLES.

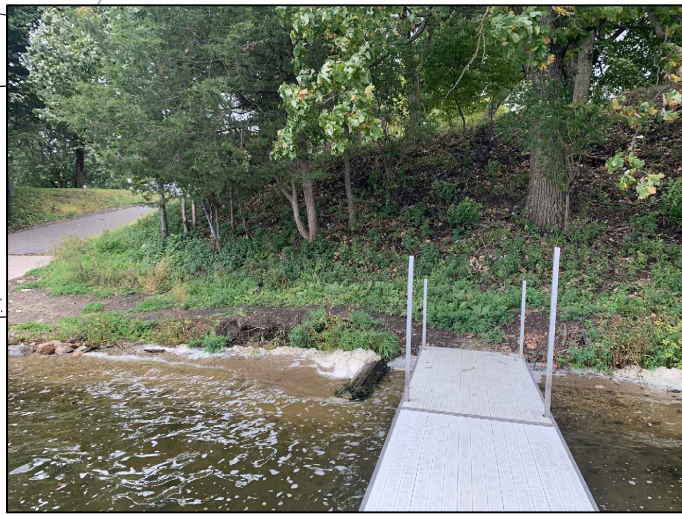
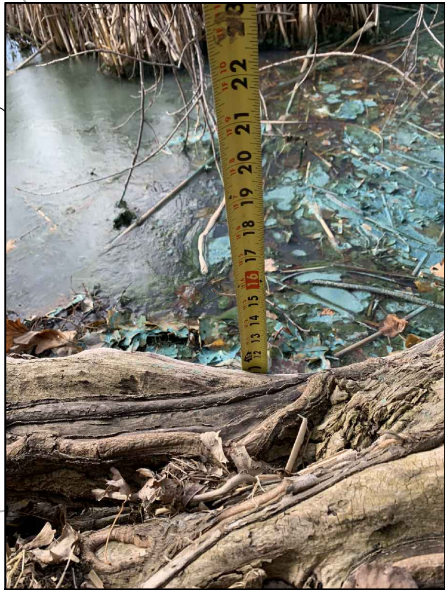
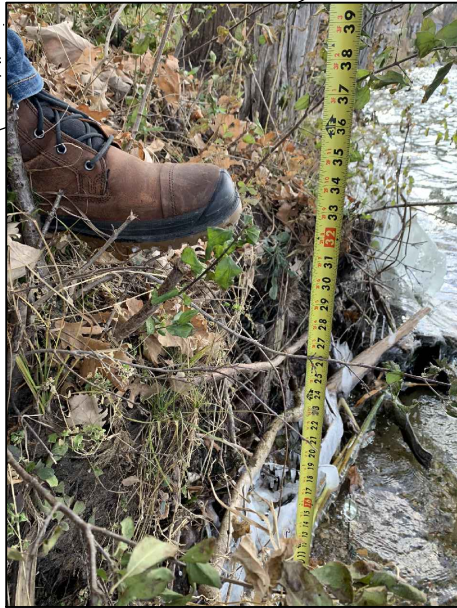
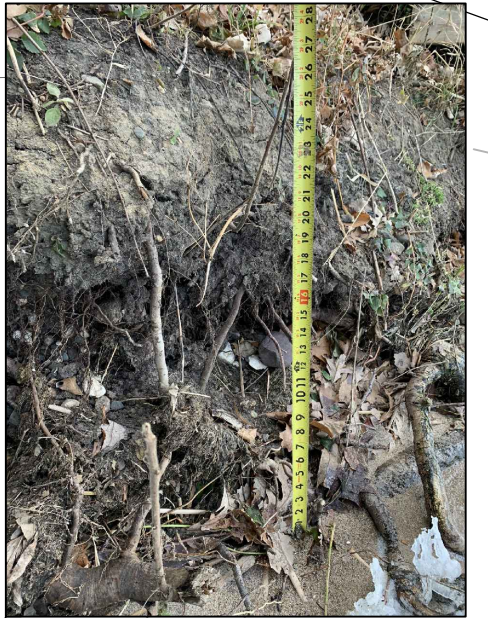
SHEET
3
OF
5
SHEETS

NOTE: RIPRAP ONLY TO ELEVATION OF ACTIVE
EROSION IN ACCORDANCE WITH DNR PERMIT
CONDITIONS. DO NOT PLACE RIPRAP OVER
AREAS WITH ESTABLISHED VEGETATION

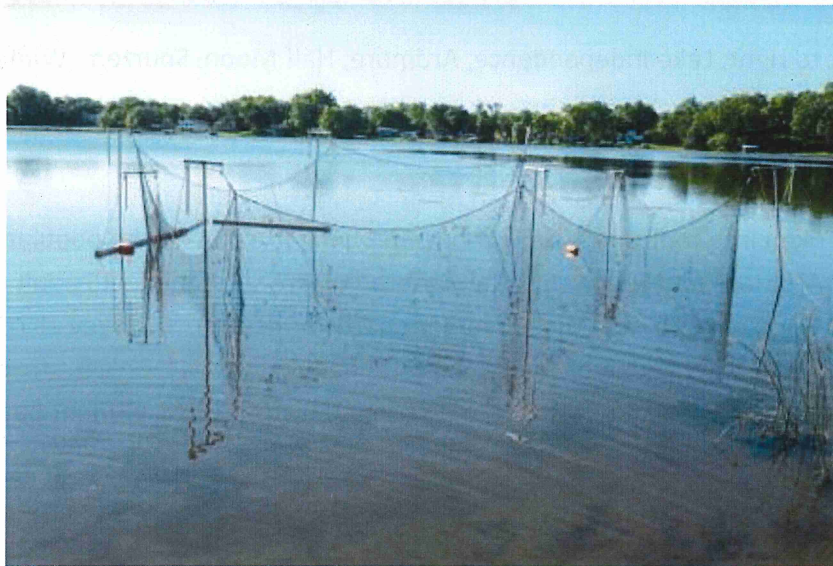
Figure 2: A box net (with the walls raised) used to catch carp that are attracted at night to bait placed in the center of the net (photo: Anita Jader).

The 2016 estimate in Ardmore was conducted using slightly different approach. A box net was used to mark and release 466 carp (most were marked on one day), and angling was then used on one day to determine recapture rates. A total of 84 carp were sampled using angling, including 35 recaptures. These numbers allowed us to estimate the population using a single census analysis (Chapman estimator) where N is number in the population, C is the number captured on the second visit, M is the number marked on the initial visits, R is the number recaptured on the angling visit:

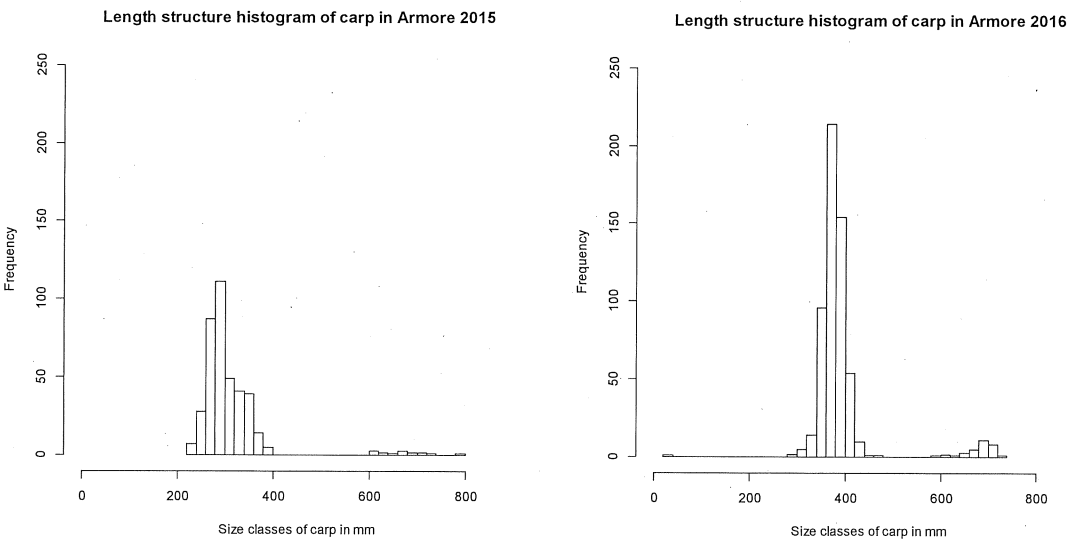
Figure 3: Length structure of carp in Ardmore Lake in 2015 and 2016.

Using the numbers of marked (466) and captured (84) and recaptured (35) carp we estimated that Lake Ardmore was inhabited by approximately 11,02 carp in 2016. This number included only carp <500 mm, because only those carp were marked and recaptured. Just like in 2015, we estimated the number of large carp in Ardmore (carp > 500 mm; mean weight 0.78 kg) using length structure, which suggested that additional 61 large carp (mean weight 3.8 kg) were present in the lake. Altogether, the biomass of carp in Ardmore in 2016 was 205 kg/ha.

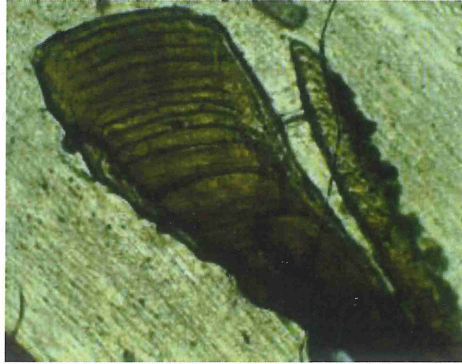
Figure 5: A cross-sectioned otolith under a microscope.

During the recapture angling event in Ardmore in 2015 and 2016 referenced in task 1, the carp were euthanized and their otoliths were removed. In addition, all carp captured during electrofishing surveys in Spurzem in 2016 were also kept for ageing. When cross-sectioned and observed under a microscope, otoliths show growth checks like tree rings. These checks correspond to each year of growth and their sum indicates the carp's age (Fig. 5).

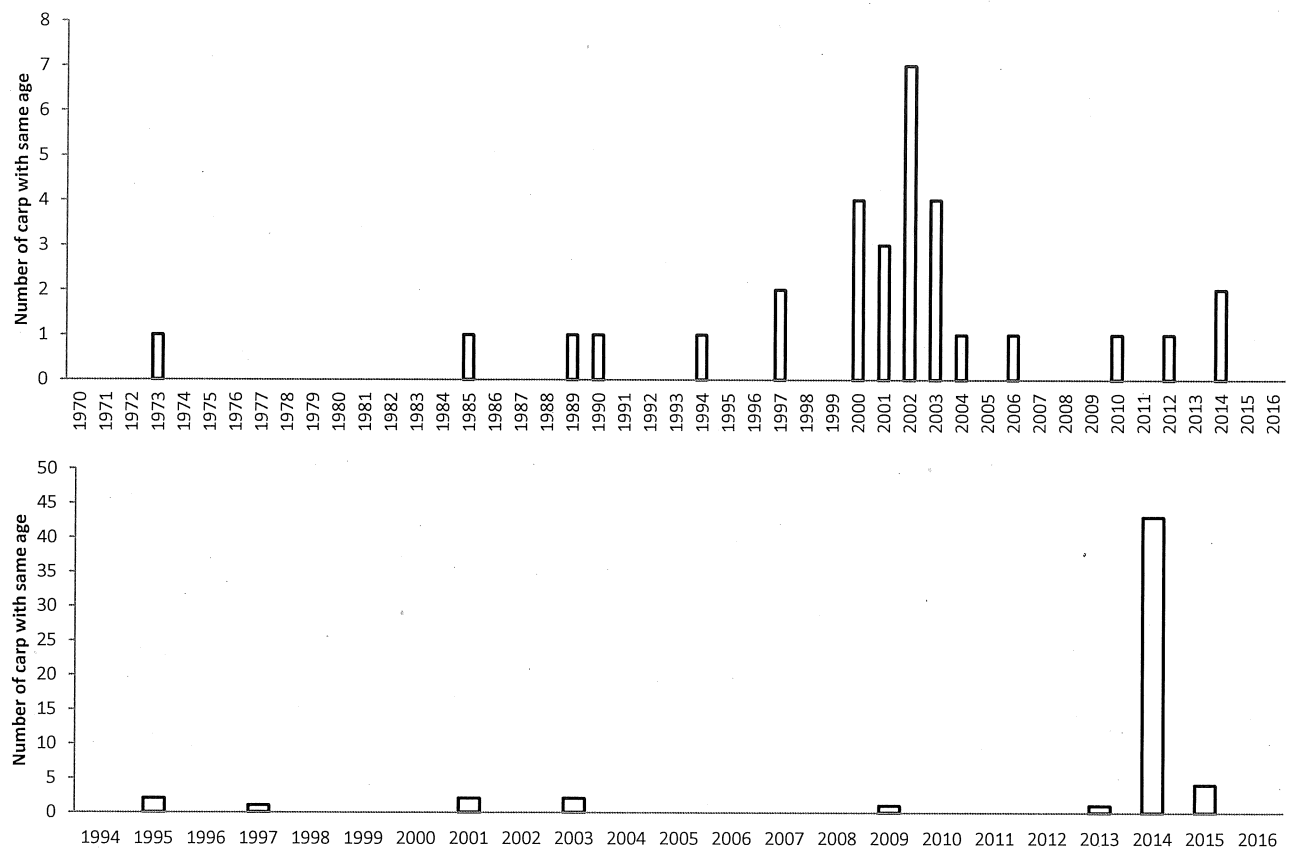
Figure 6: Common carp age structure in lakes Spurzem (top) and Ardmore (bottom). Shown are years in which carp were born.

By plotting the aggregate age structure, we examined recruitment history patterns in each lake. The population of carp in Ardmore was dominated by the 2014 year class (Fig. 6), with several other year classes being present in very low numbers. In Spurzem, no strong recruitment events were detected in recent years and the population was dominated by the 2000-2003 year classes (Fig. 6).

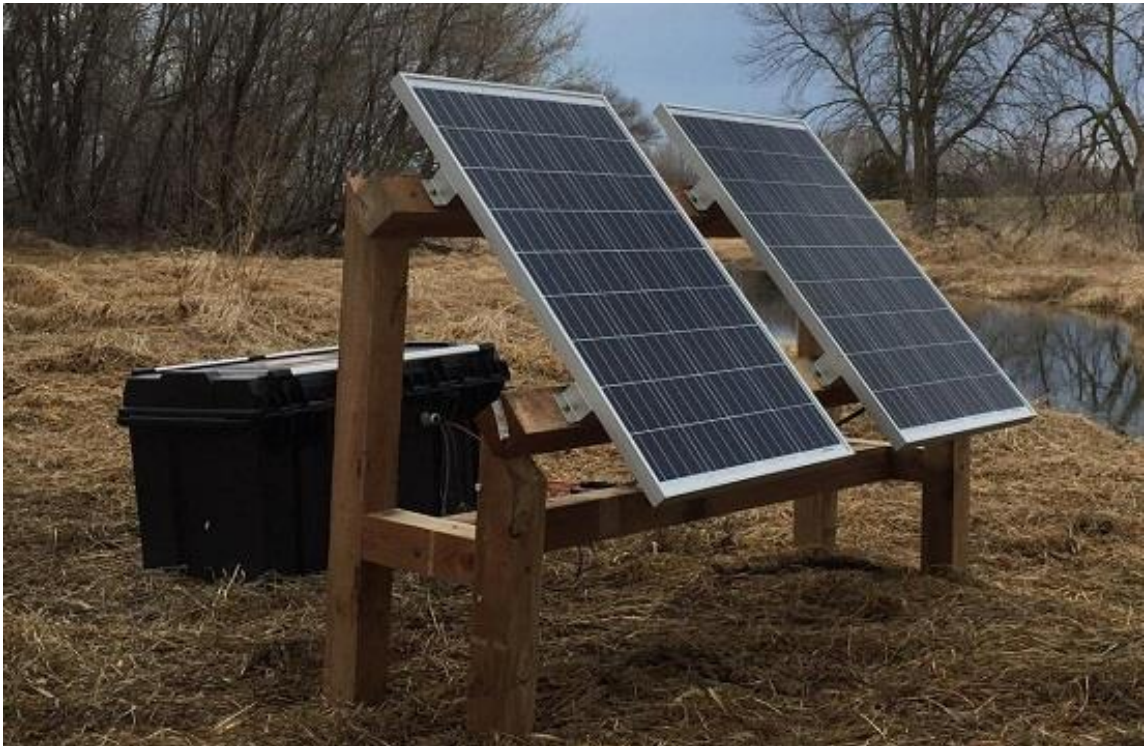
Figure 4: PIT antenna station installed near a potential carp migration route.

Antenna systems, like the one displayed in Figure 4, capable of detecting carp implanted with microtransmitter PIT tags (~ 12 mm in length, 3 mm in diameter) were positioned around culverts in three locations: within Ardmore Creek, at the culvert leading under Highway 19, and near the culvert at Pagenkopf Avenue near the southwest outlet of Independence (Figure 1) in order to monitor carp passage between the lakes. The data gathered by those antennas will determine if future barrier(s) is/are needed to block the movement of carp.

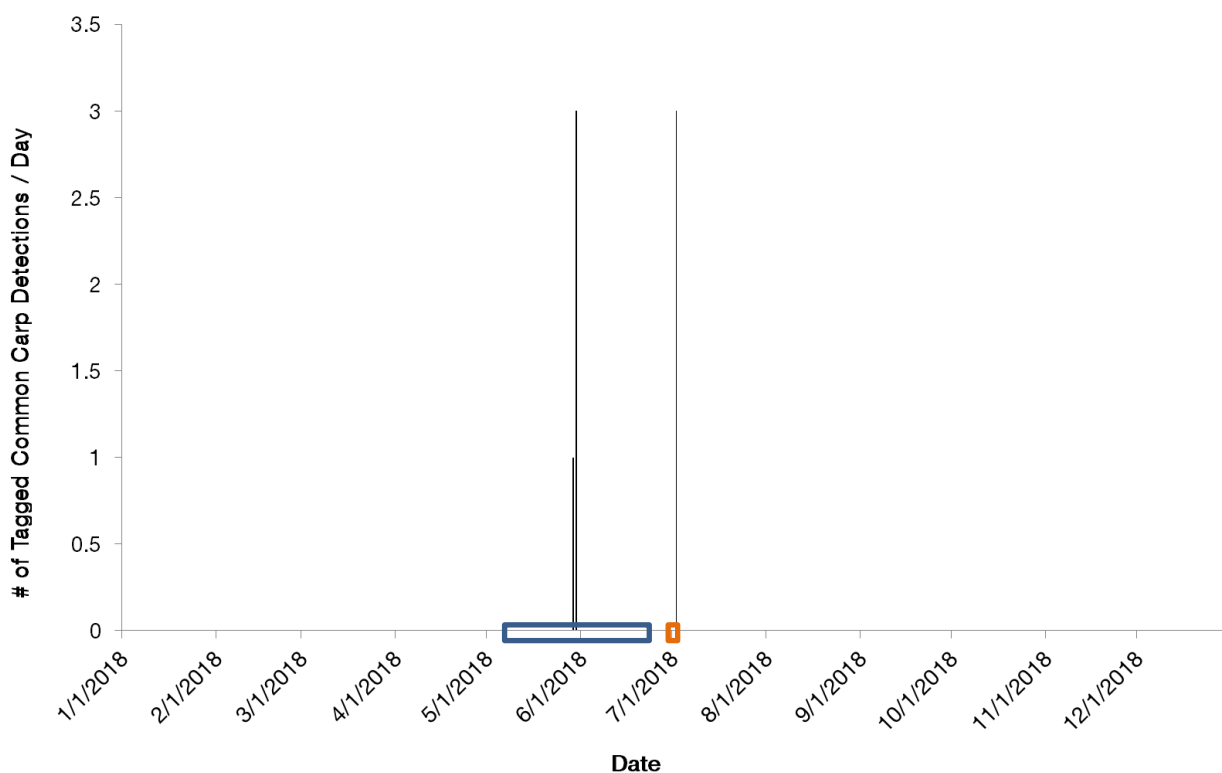
Figure 5. Number of tagged carp detected at Ardmore Creek site. Blue box indicates the tagging period in Independence, and the orange indicates the tagging period in Ardmore

This site (solar powered) has suffered daily power loss ranging from 4-8 hours late at night through dawn due to poor solar exposure. One week after installation, we doubled the area of solar panels (~\$200) and invested in extra equipment (~\$1000) that allowed the panels to be moved farther away from the PIT system in an attempt to remedy the problem, but this was unsuccessful. This system should be moved to a spot with open southern solar exposure for 2019 season or connected to permanent power from a nearby resident.

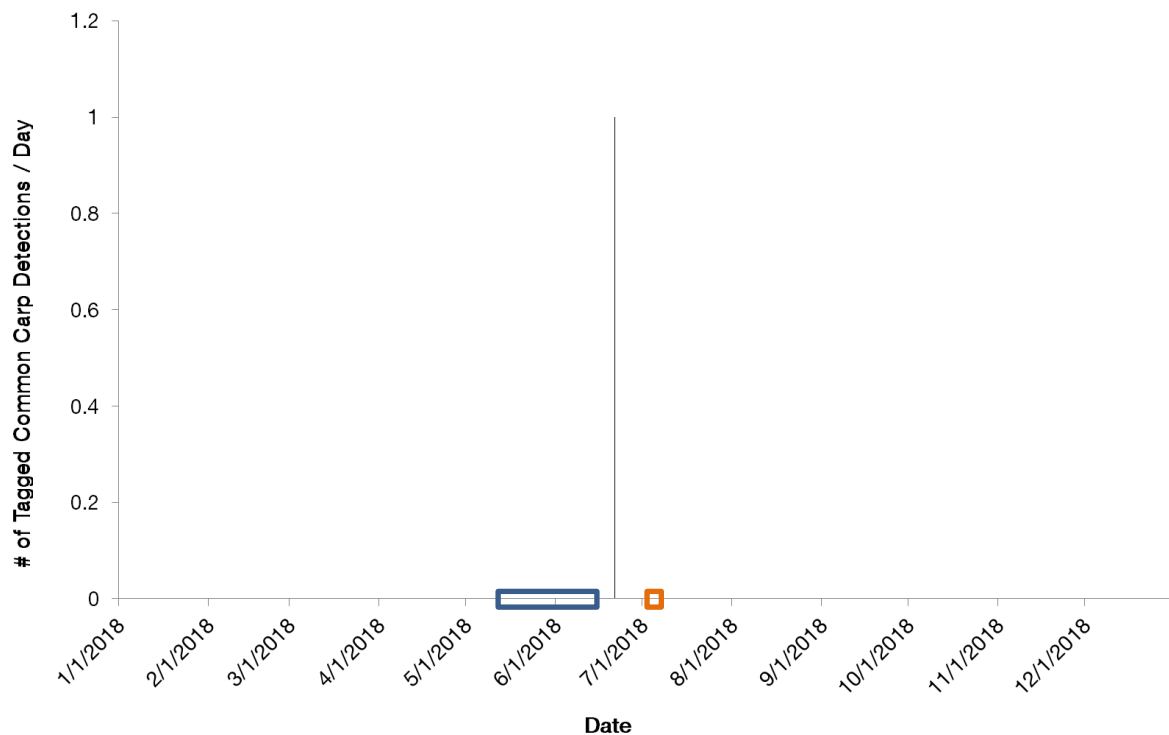
Figure 6. Number of tagged carp detected by day at Highway 19 site. Blue box indicates the tagging period in Independence, and the orange indicates the tagging period in Ardmore

There has only been a single common carp detected at this site (tagged in Lake Independence), moving upstream towards Half Moon Lake on 6/21/18. Interestingly, this fish was also the tagged carp that moved upstream to Ardmore Lake on 5/29/18. This site has not suffered power loss since installation.

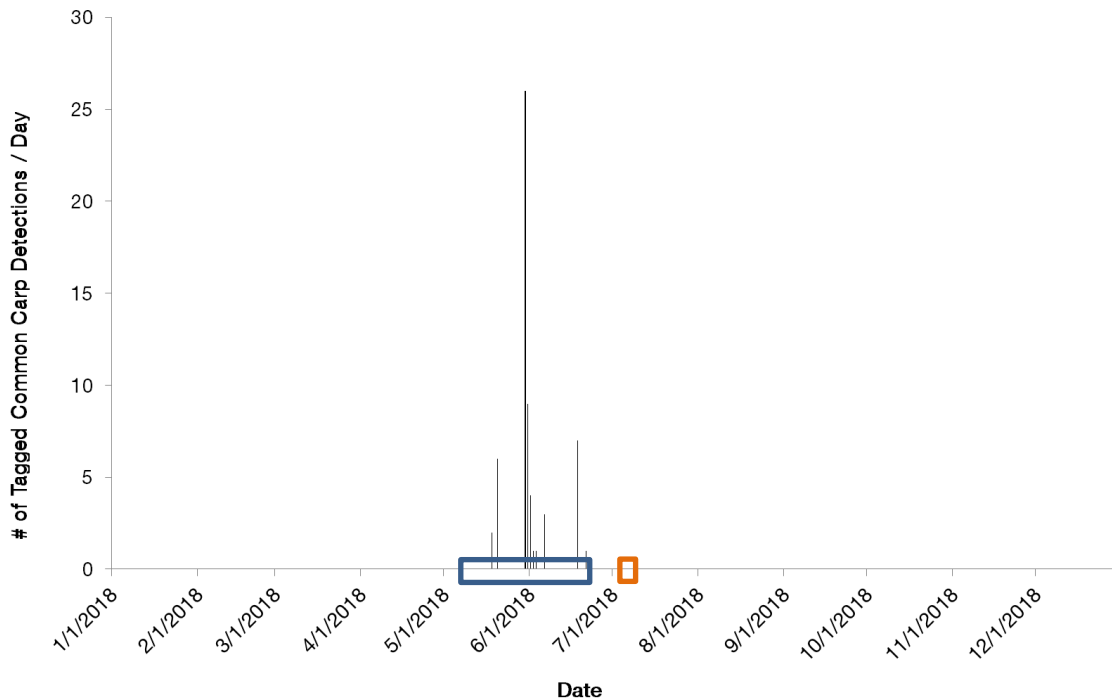
Figure 7. Number of tagged carp detected by day at Pagenkopf Ave site. Blue box indicates the tagging period in Independence, and the orange indicates the tagging period in Ardmore

There were 33 tagged carp detected at this site in May and June of 2018, all of which were tagged in Lake Independence (Figure 7). These fish were moving downstream likely to spawn.

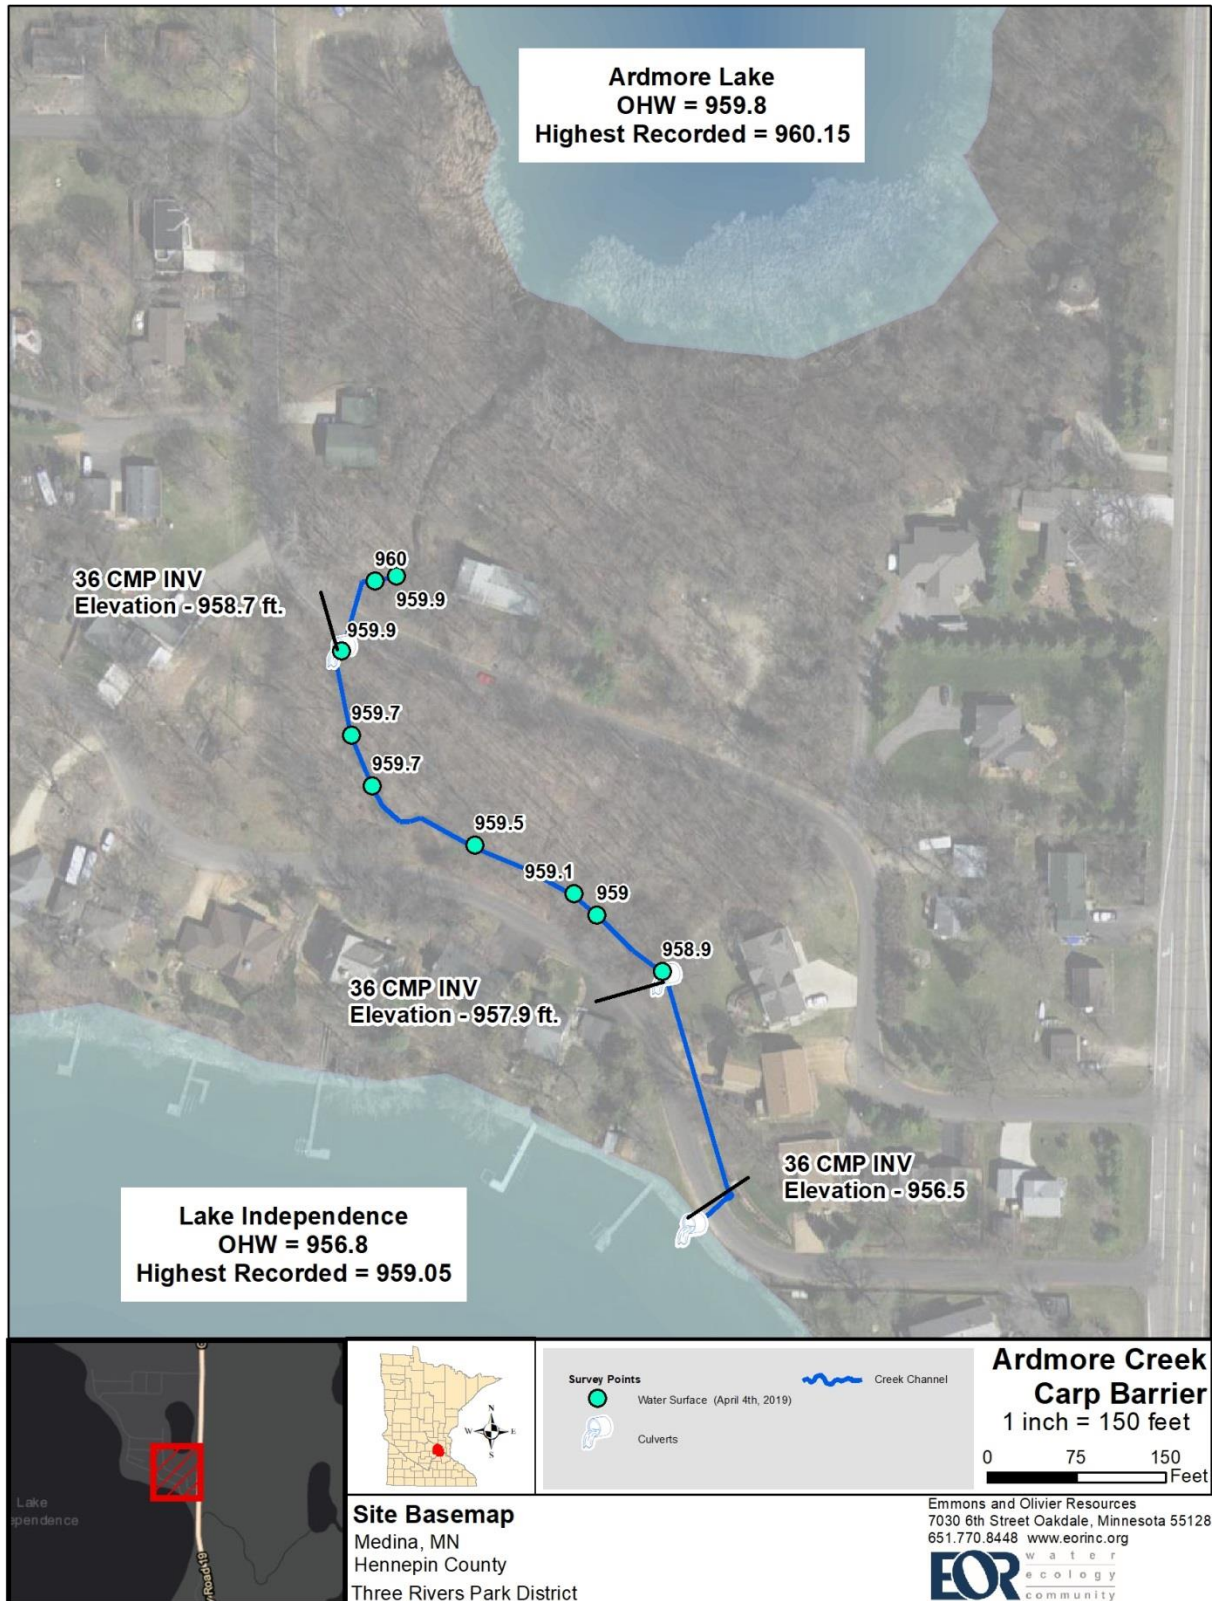
Figure 1. Ardmore Channel Profile and Culvert Elevations (Point Elevations Represent Water Surface Elevations)

There appears to be sufficient gradient within the Ardmore outlet channel between Ardmore Avenue and Lake Shore Avenue to install a shallow rock riffle fish barrier. The concept design would entail construction of a long and shallow rock riffle to dissipate peak flows across a wide channel cross section such that there would be insufficient depth of water for carp to migrate upstream. Based on the outlet channel survey completed by EOR staff, there is approximately 1.0 vertical feet of channel gradient between the two road crossings (Figure 1 & Figure 2). This gradient would allow for construction of a riffle approximately 25 to 50 feet long depending on the riffle location. The width of the riffle would be designed such that peak channel flows would result in a maximum flow depth of 0.25 feet across the entire riffle.

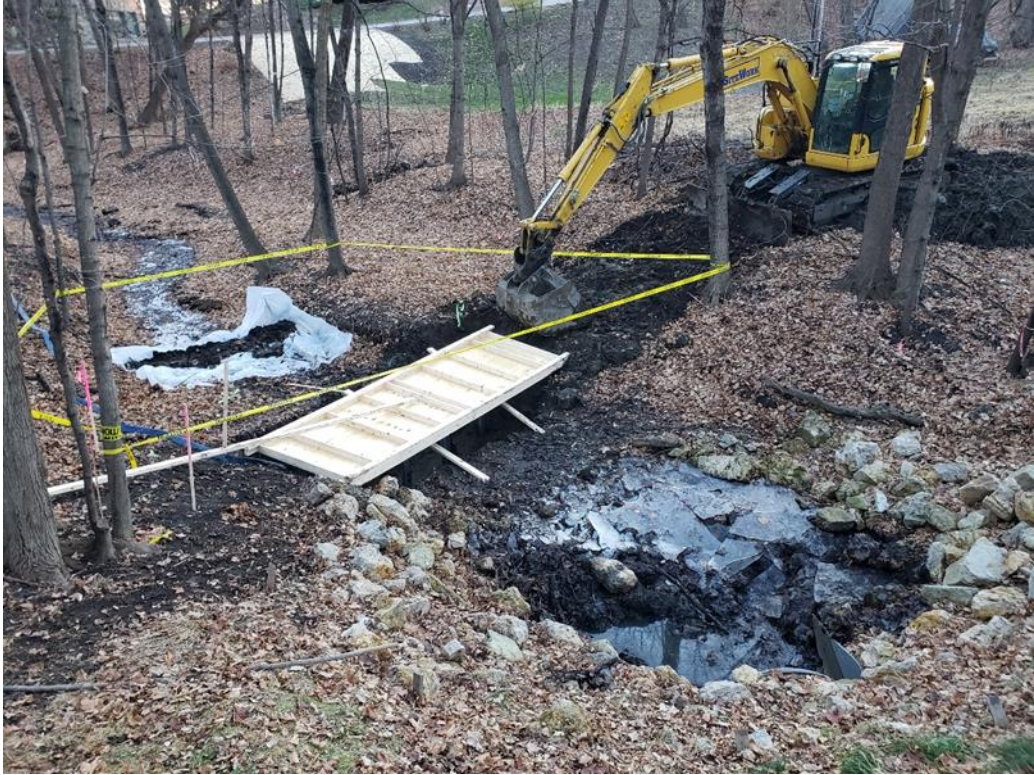
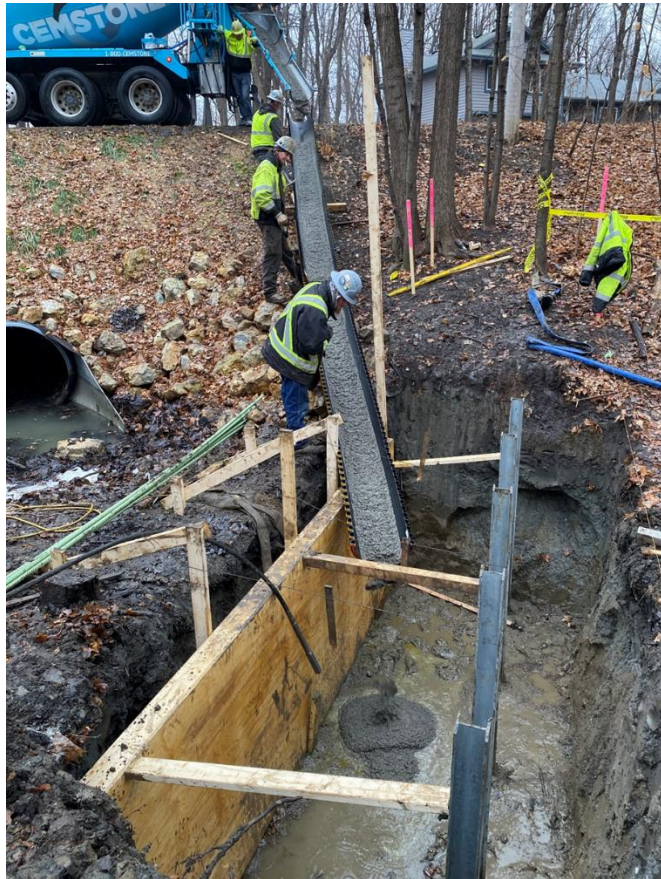
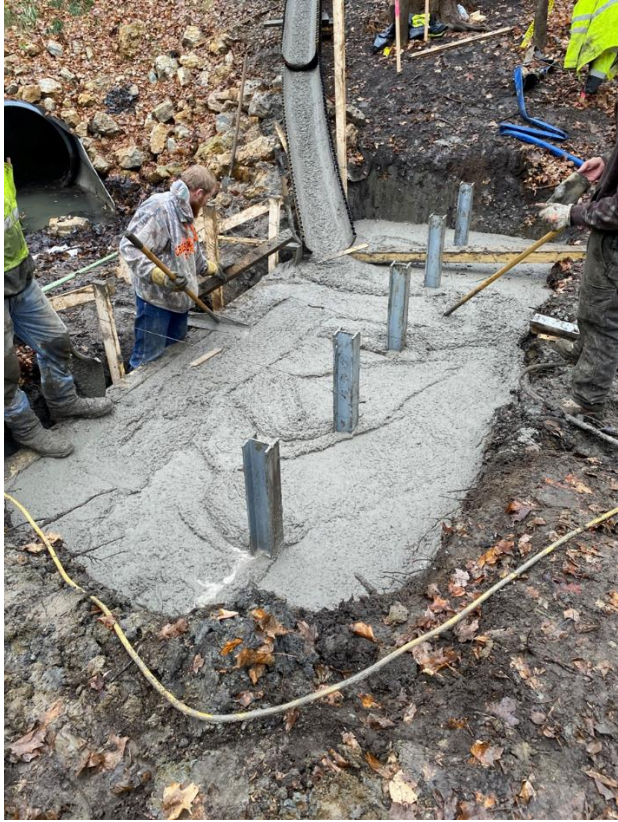
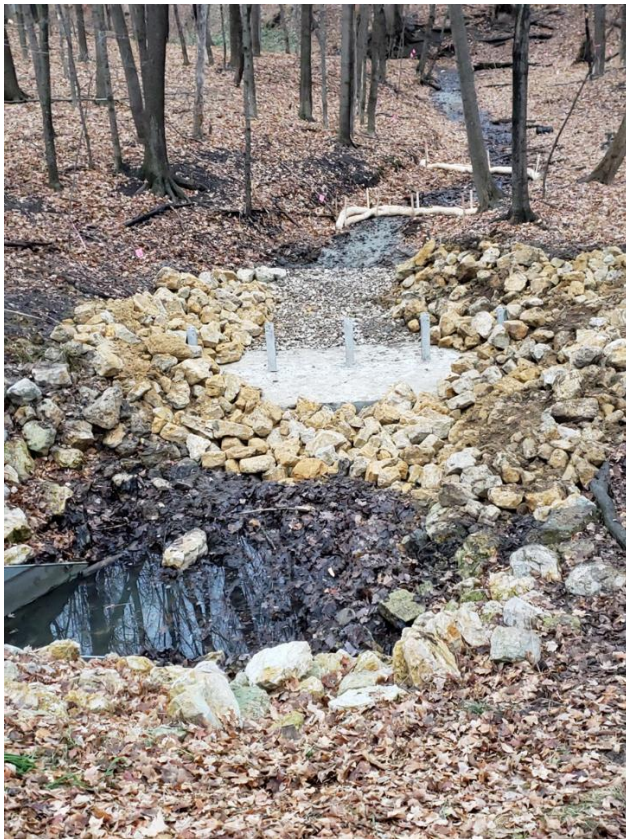
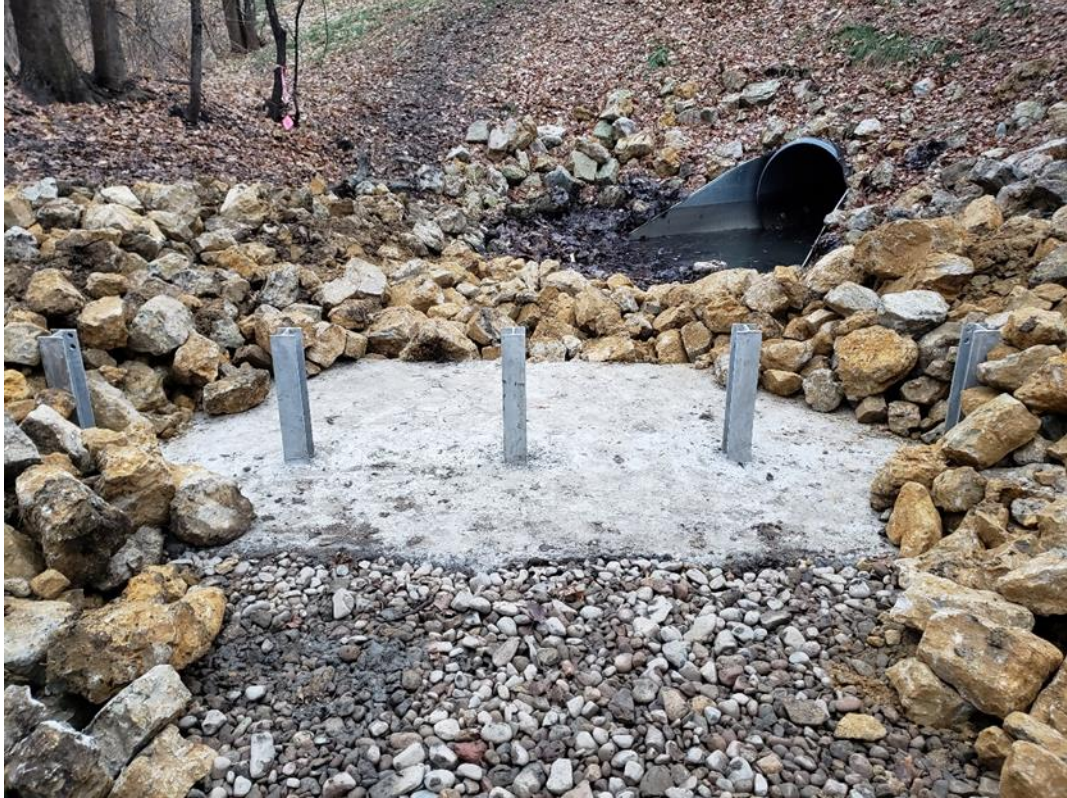
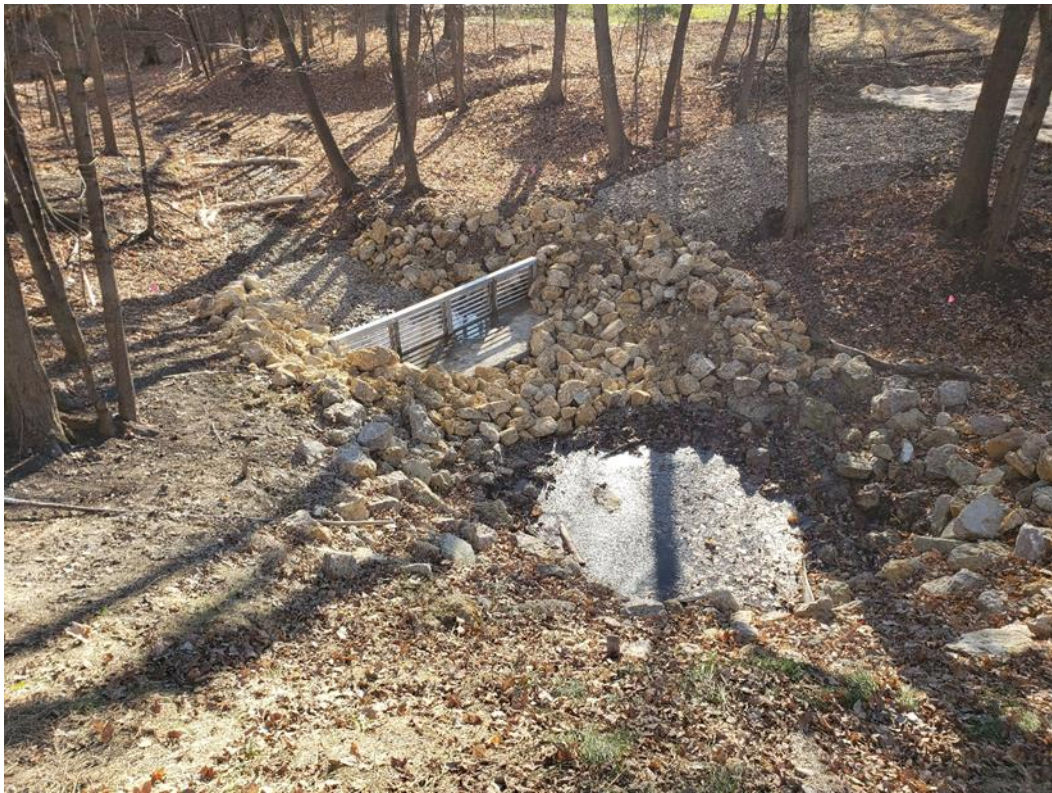
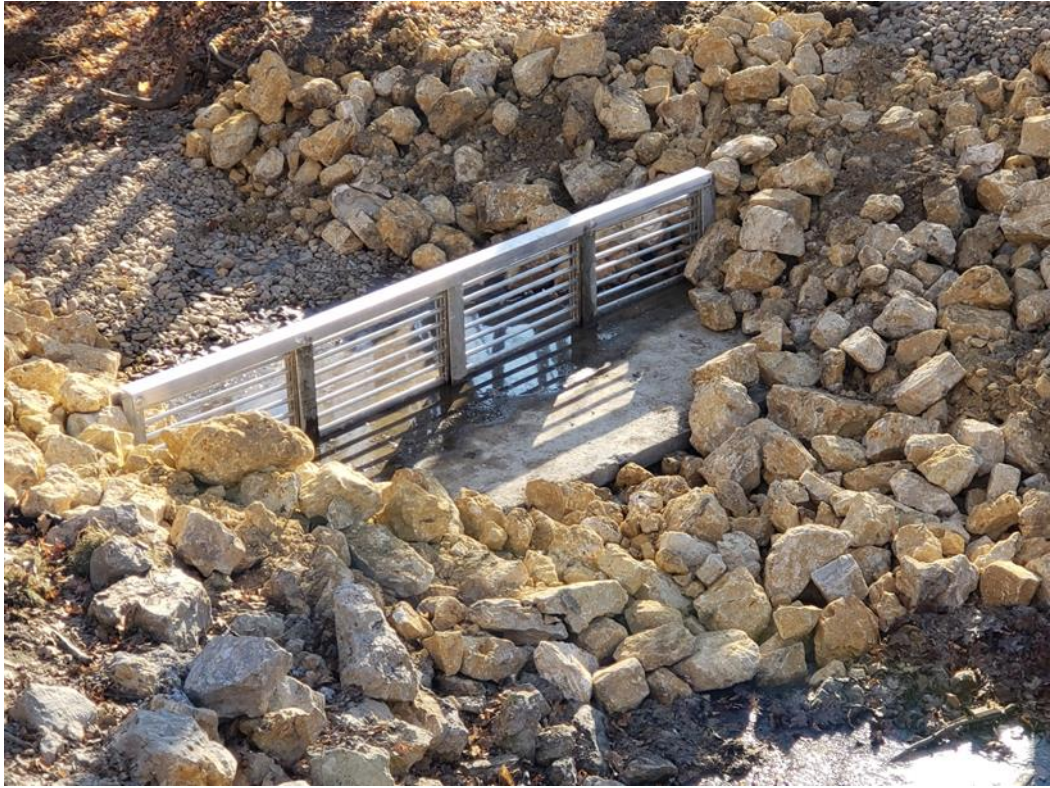
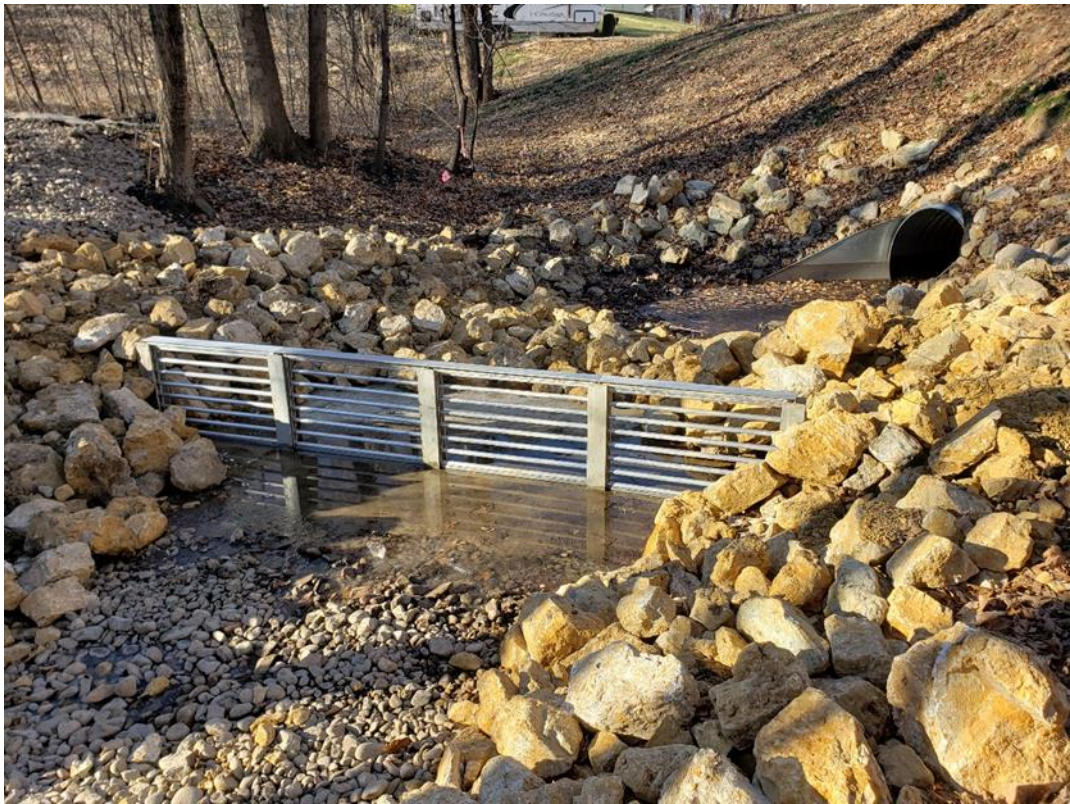
An Ardmore Channel Carp Barrier Feasibility Study was conducted in 2019 to consider different options that would prevent carp migration between Lake Independence and Ardmore Lake. The study recommended a removable fish grate in the open channel located downstream of the Ardmore Lake outlet culvert on Ardmore Avenue. The design plans and permits for the project were completed/acquired in the spring of 2020. The construction of the carp barrier was just recently installed by U.S. SiteWork during the week of November 23rd through 30th, 2020. This was a collaborative project between Pioneer-Sarah Creek Watershed Management Commission, City of Medina, Hennepin County, Board of Water and Soil Resources, and Three Rivers Park District. The final project costs for the design/permitting and construction/installation of the carp barrier was \$58,092. The following photos were taken during the installation of the carp barrier.

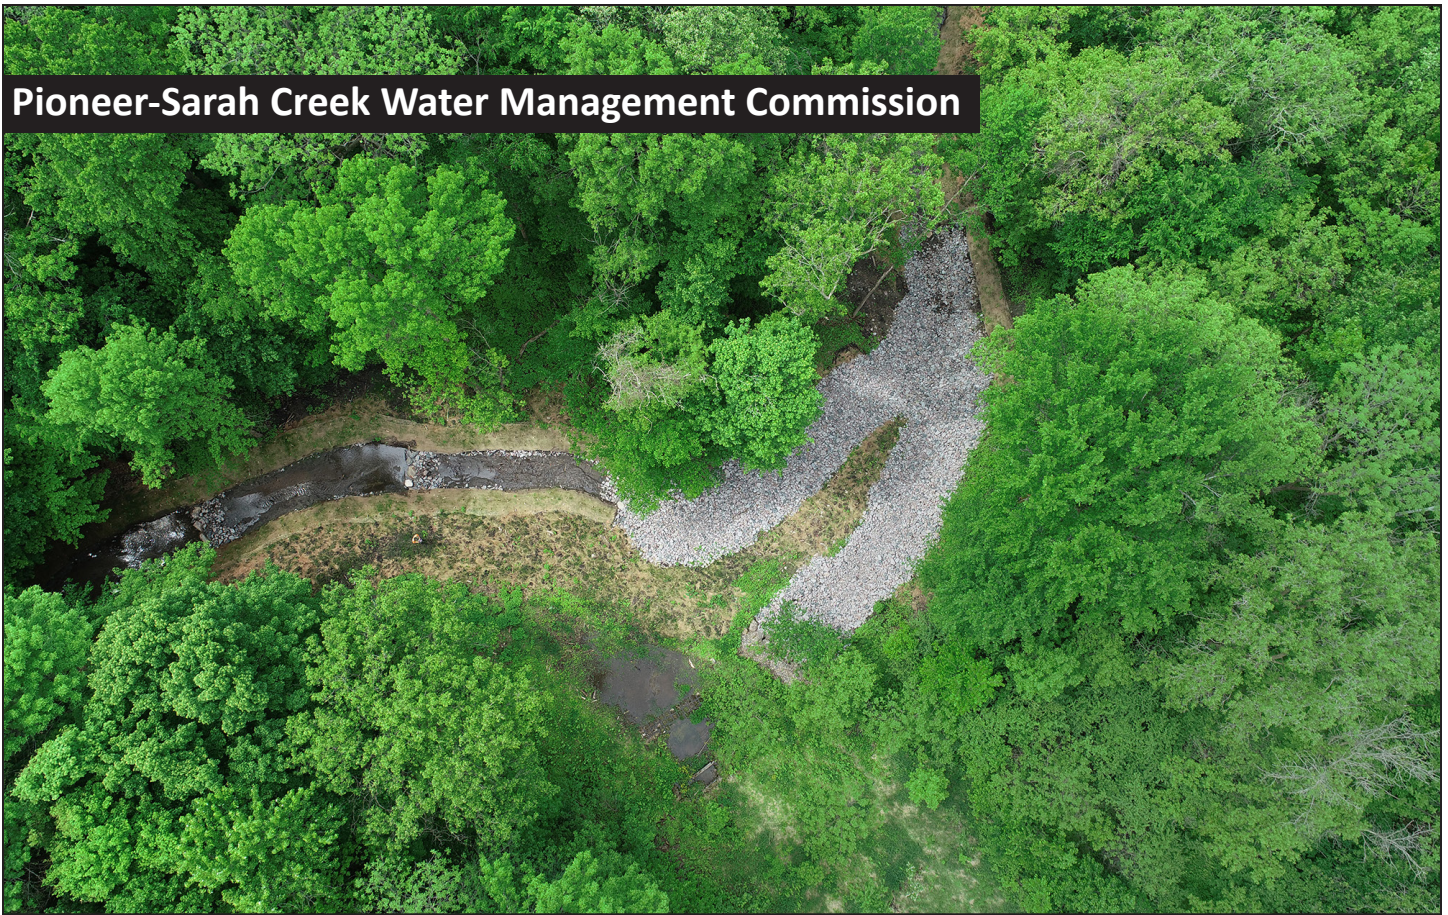
Top: By late May, the re-sloped ravine stabilization in Baker Park Reserve was greening up. Seven species of wildflowers and nine grasses were planted in the dirt covering rock riprap and topped by an erosion control blanket. **Photo Credit:** Wenck Associates
Right: Eric Stay of Minnesota Native Landscapes ran the excavator on Dec. 19, 2019. The project aims to reduce phosphorus-loading to nutrient-impaired Lake Independence by 134 pounds a year at a cost of \$130 per pound. **Photo Credit:** Ann Wessel, BWSR

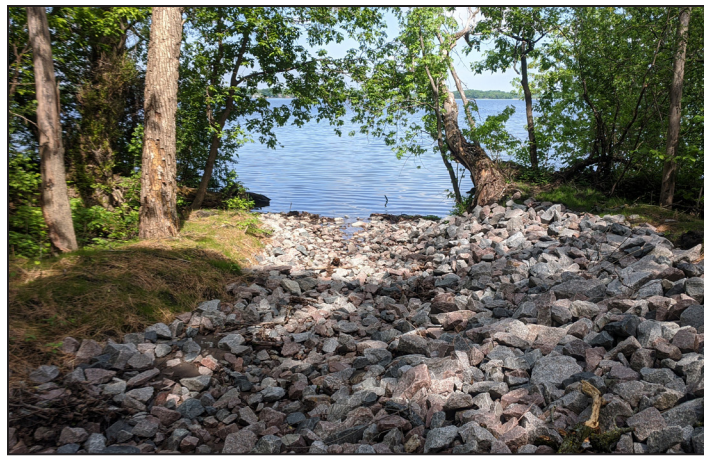
The project will curb how much phosphorus enters Lake Independence by about 15% of the reduction needed to meet Minnesota Pollution Control Agency water-quality standards. Photo Credit: Wenck Associates

Minnesota Native Landscapes crew was installing riprap and re-sloping the ravine’s banks, moving downstream toward the lake. Newly constructed rock cross-vanes, which serve as grade-control structures, stood out against the snow.

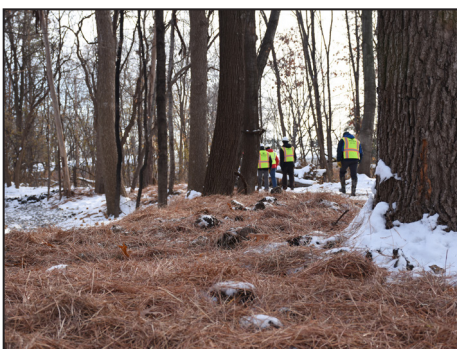
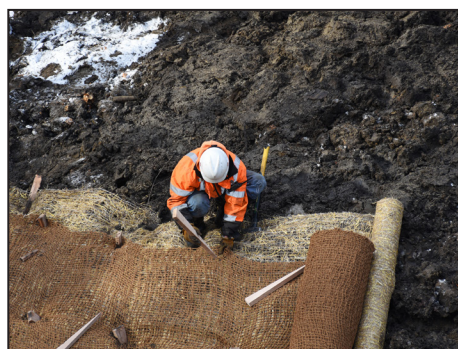
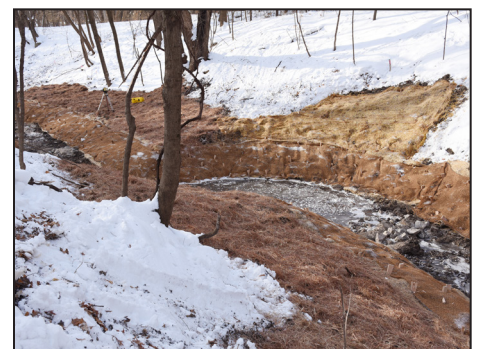
From left: Bluestem grass was used in the erosion control blanket. After a Dec. 19, 2019, construction meeting, a group from Wenck Associates, contractor Minnesota Native Landscapes, the Pioneer-Sarah Creek Watershed Management Commission, the park district and BWSR toured the site. Devan Maruska of Minnesota Native Landscapes staked an erosion control blanket. The ravine stabilization involved 1,800 feet in the main channel, plus 400 feet in two tributary ravines. Photo Credits: Ann Wessel, BWSR

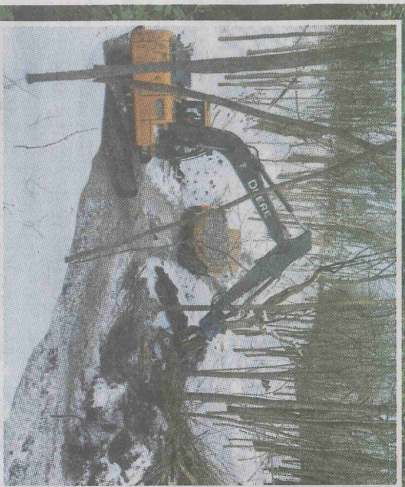
The ravine stabilization in Baker Park Reserve is designed to improve the water quality of Lake Independence. Seven species of wildflowers and nine grasses were planted in the dirt covering rock riprap and topped by an erosion-control blanket.
